# Perrigo Community Park Master Plan Amendment Design Report for Park Addition

May 2008

# Perrigo Community Park Master Plan Amendment

## Design Report for Park Addition

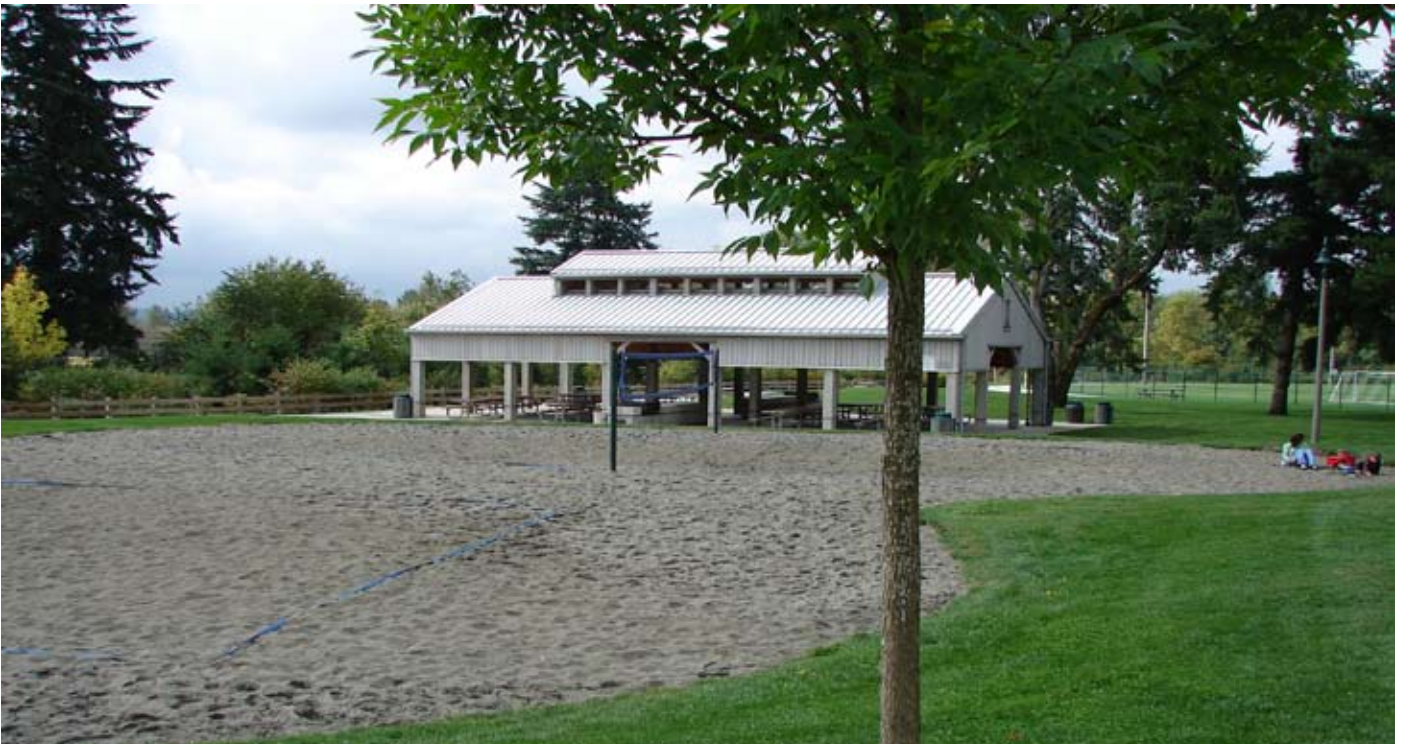
view of sand volleyball area in existing park that is commonly used by young children. adding a designated sand digging area in the new park is a potential solution

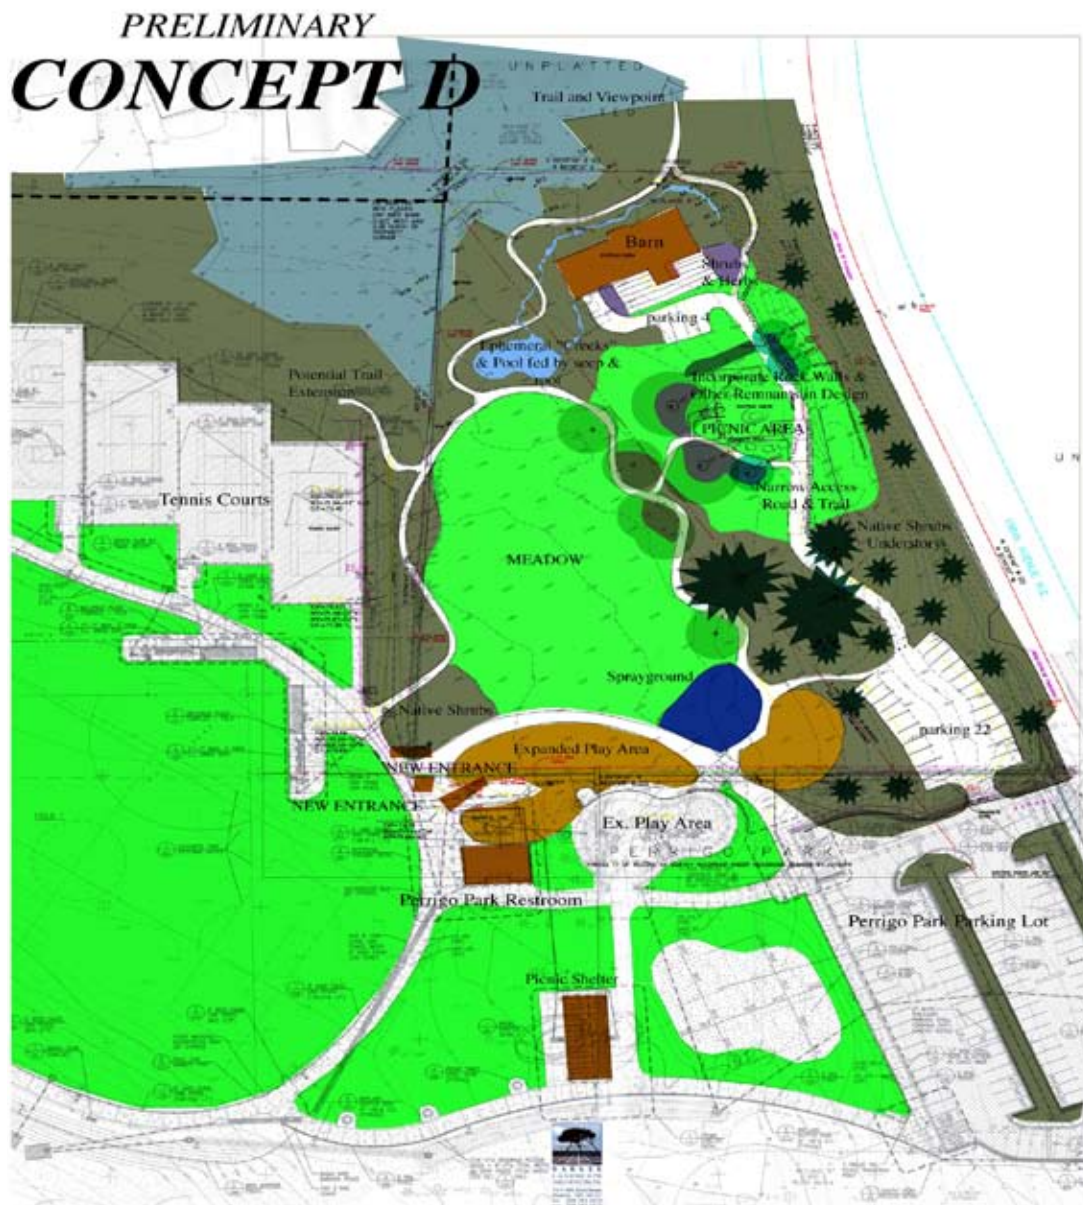
Plan D was drawn after the January PTC meeting and in response to staff comments.

January 3, 2008 (FIRST PUBLIC MEETING) A presentation and discussion with the Redmond Parks and Trail Commission occurred to begin to introduce ideas and images about how the City's goals can be realized. Comments centered around how much parking is appropriate for this site, and additional staff review resulted in refinements shown on the next page (Concept D).

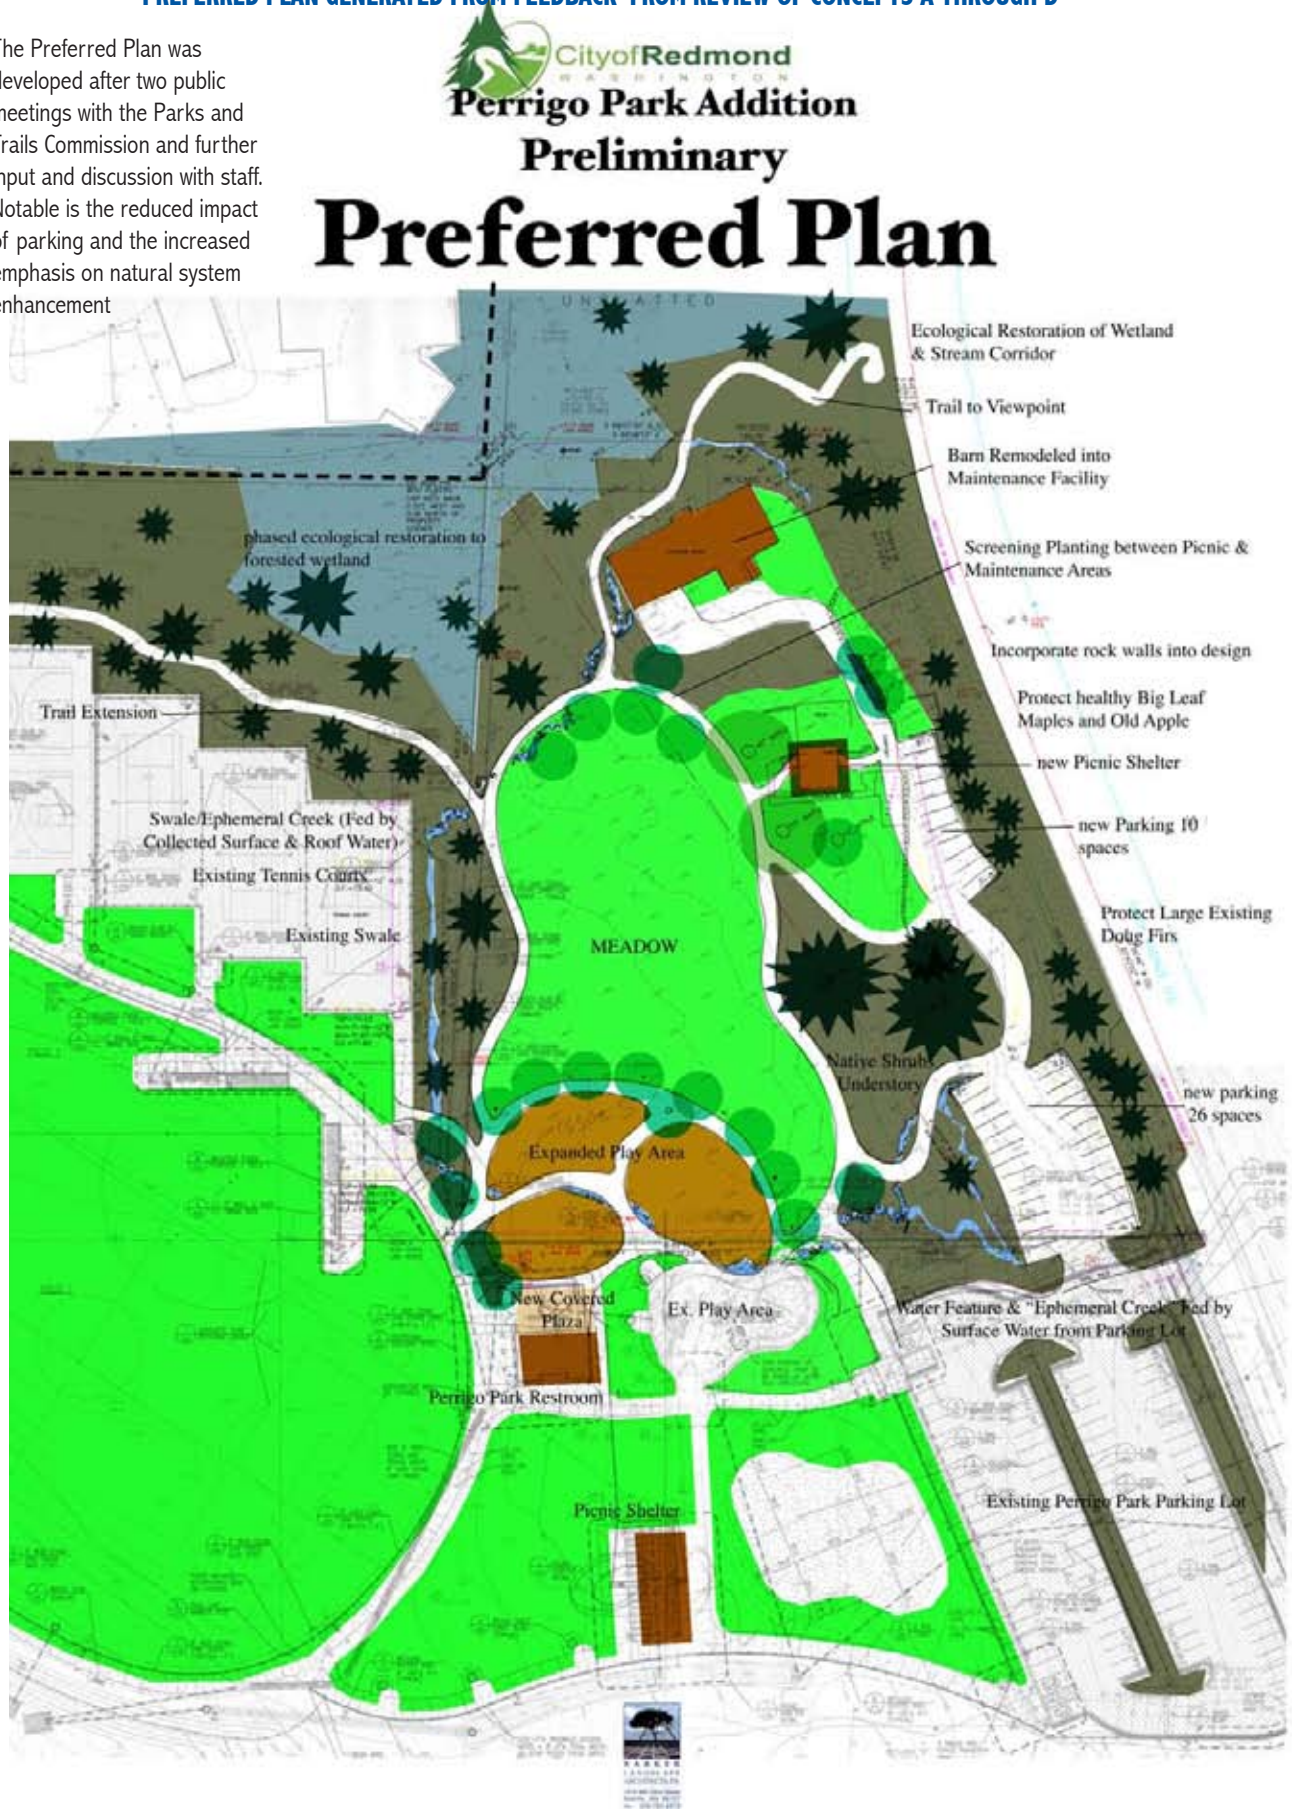
## PREFERRED PLAN GENERATED FROM FEEDBACK FROM REVIEW OF CONCEPTS A THROUGH D

The Preferred Plan was developed after two public meetings with the Parks and Trails Commission and further input and discussion with staff. Notable is the reduced impact of parking and the increased emphasis on natural system enhancement

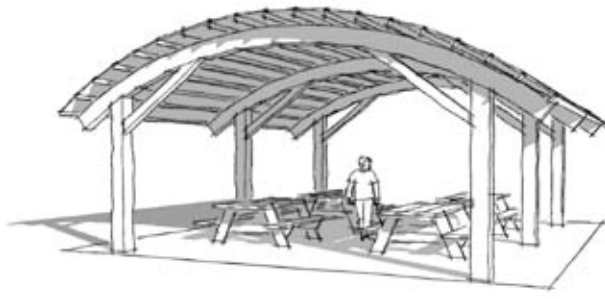
Potential design for new picnic shelter

- New picnic shelter with a capacity of 24 people (approximately 1000 s.f.) near the existing barn, related in design to the farm and the barn, near the site of the old house.

picnic shelter freestanding	ea	1	\$100,000.00	\$100,000	970 SF freestanding shelter
picnic shelter attached	ea	1	\$50,000.00	\$50,000	940 SF attached to existing restroom/storage

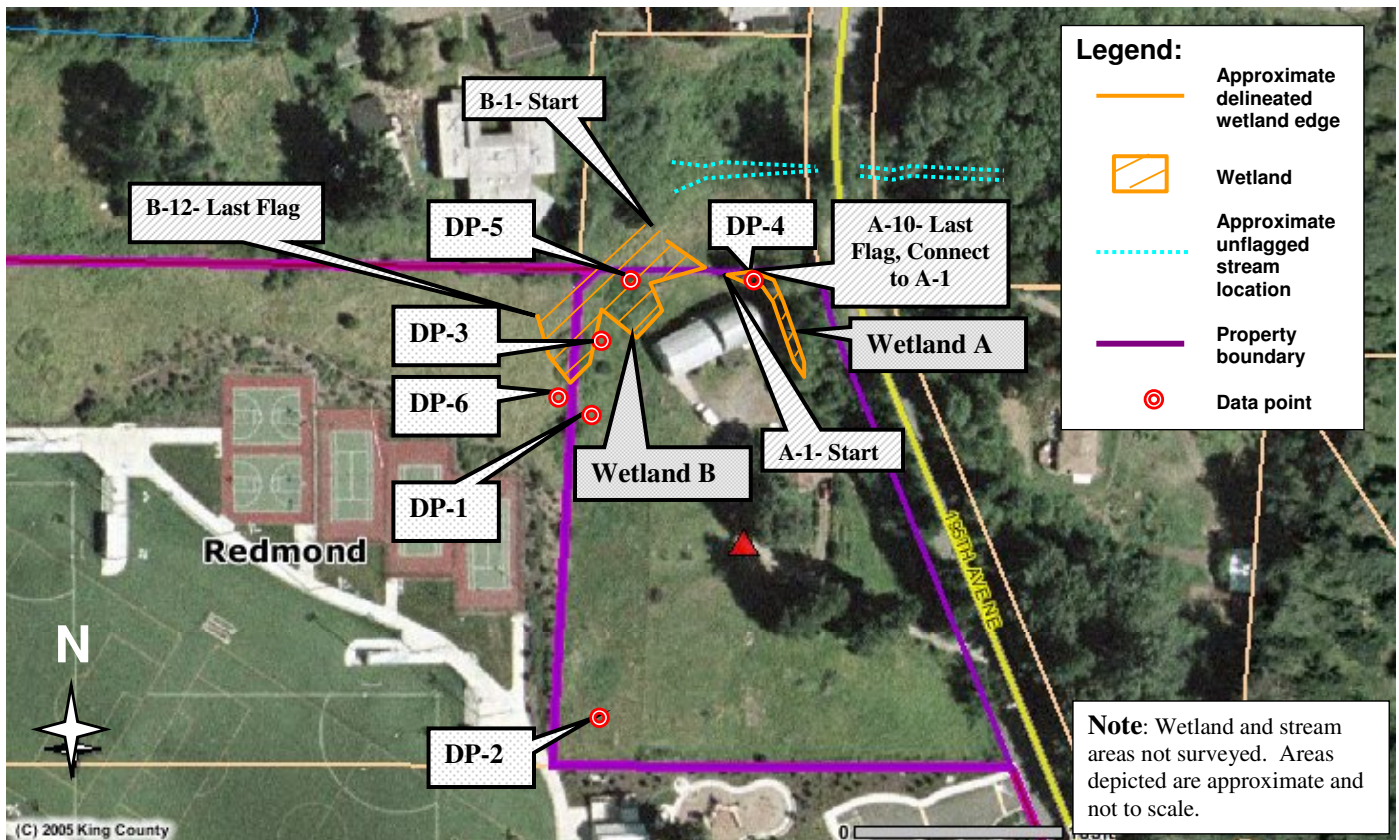
#### Wetland Delineation Sketch

(parcel number 0625069100)

Wetland A appears to have been created when the hillside to its east was excavated in order to situate the current on-site barn structure. This excavation now intercepts the groundwater table that also supports the larger wetland system found to the north and west. Dominant vegetation in this wetland consists of soft rush (*Juncus effusus*), orchard grass (*Dactylis glomerata*) and bluegrass species (*Poa* sp.) with cottonwood (*Populus balsamifera*), creeping buttercup (*Ranunculus repens*) and geranium (*Geranium* sp.) also present. Soils are dominated by gleyed greenish gray (Gley 1 5GY5/1) sandy clay loam with dark yellowish brown (10YR4/6) redoximorphic features (RMFs). Free water was observed at the surface at the time of our visit, and approximately 1/4 inches of sheet flow was present in surface depressions nearby.

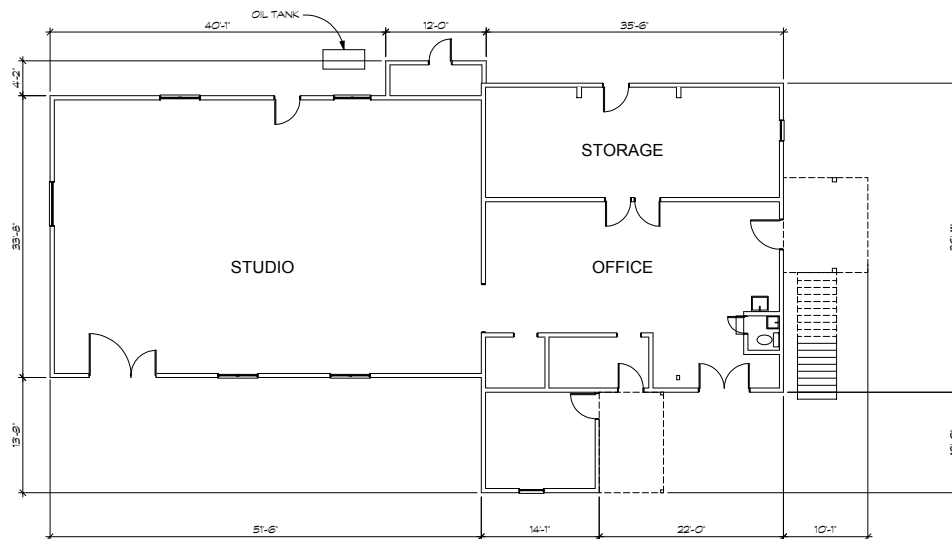
1 First Floor Plan  
A2.1 Scale: 1/8" = 1'-0"

## Floor Plans

the original roof is arched with the ridge running approximately east-west. the roof structure is entirely enclosed so it is not possible to analyze the framing. the upper floor appears to have been reframed when the west wing was added. the floor structure is 14" plywood-web joists @ 16"o.c spanning north south, supported on the exterior walls and an interior load bearing wall. the roof of the west wing is framed with prefabricated connector plate wood trusses spanning north-south. the main floor is a concrete slab on grade and all the foundations appear to be continuous concrete footings with concrete stem walls.
